Technical Report 421

RESISTANCE OF COATED AND UNCOATED IR WINDOWS TO SEAWATER CORROSION

JD Stachiw
(Naval Ocean Systems Center)
SL Bertic
(San Diego State University)

15 August 1979

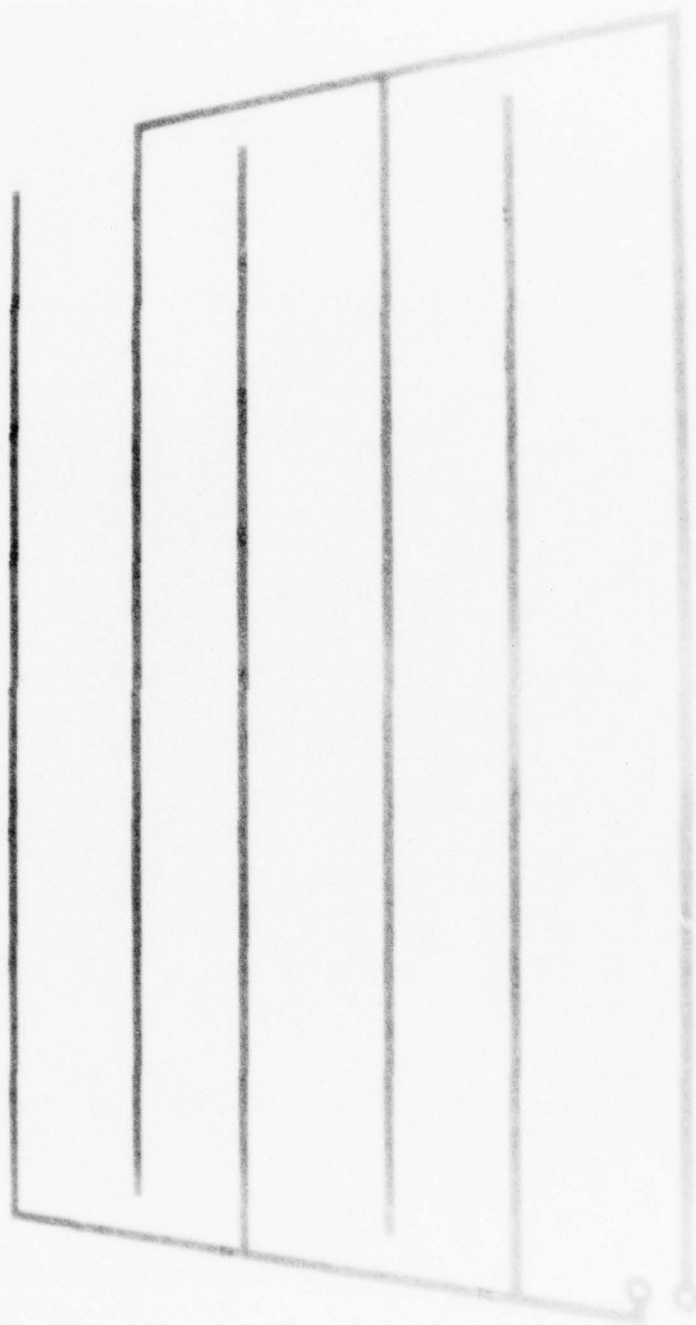
Figure 12. Printed circuit board for fixture C.

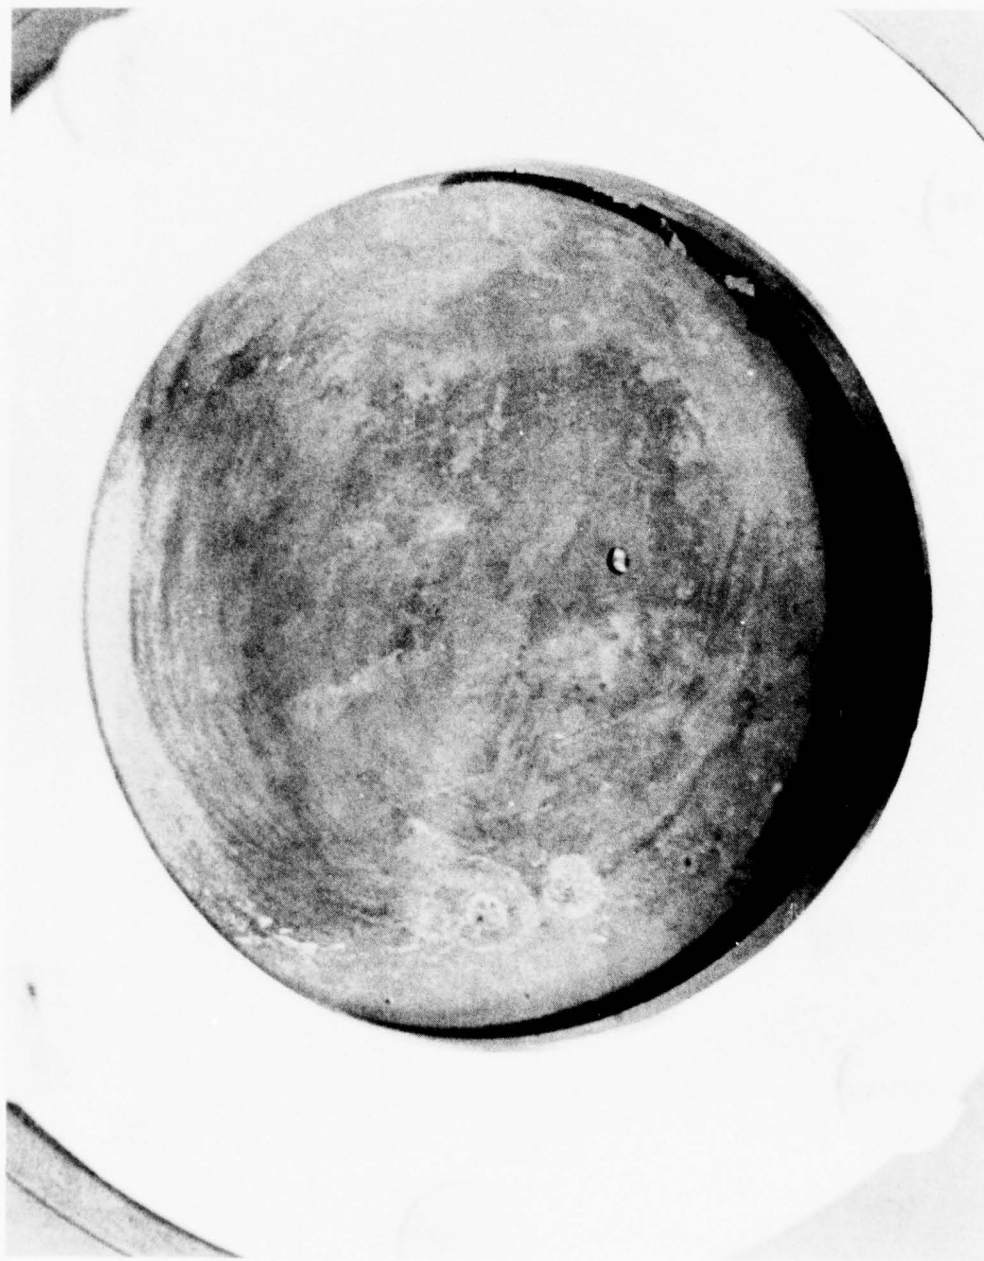
Figure 39. A specimen of AMTIR-1 glass after one month of testing with natural circulation in San Diego Bay.

The only non-germanium specimens, the chalcogenide germanium glass AMTIR-1, showed no corrosion or change of physical condition throughout the testing period (figures 39 and 40).

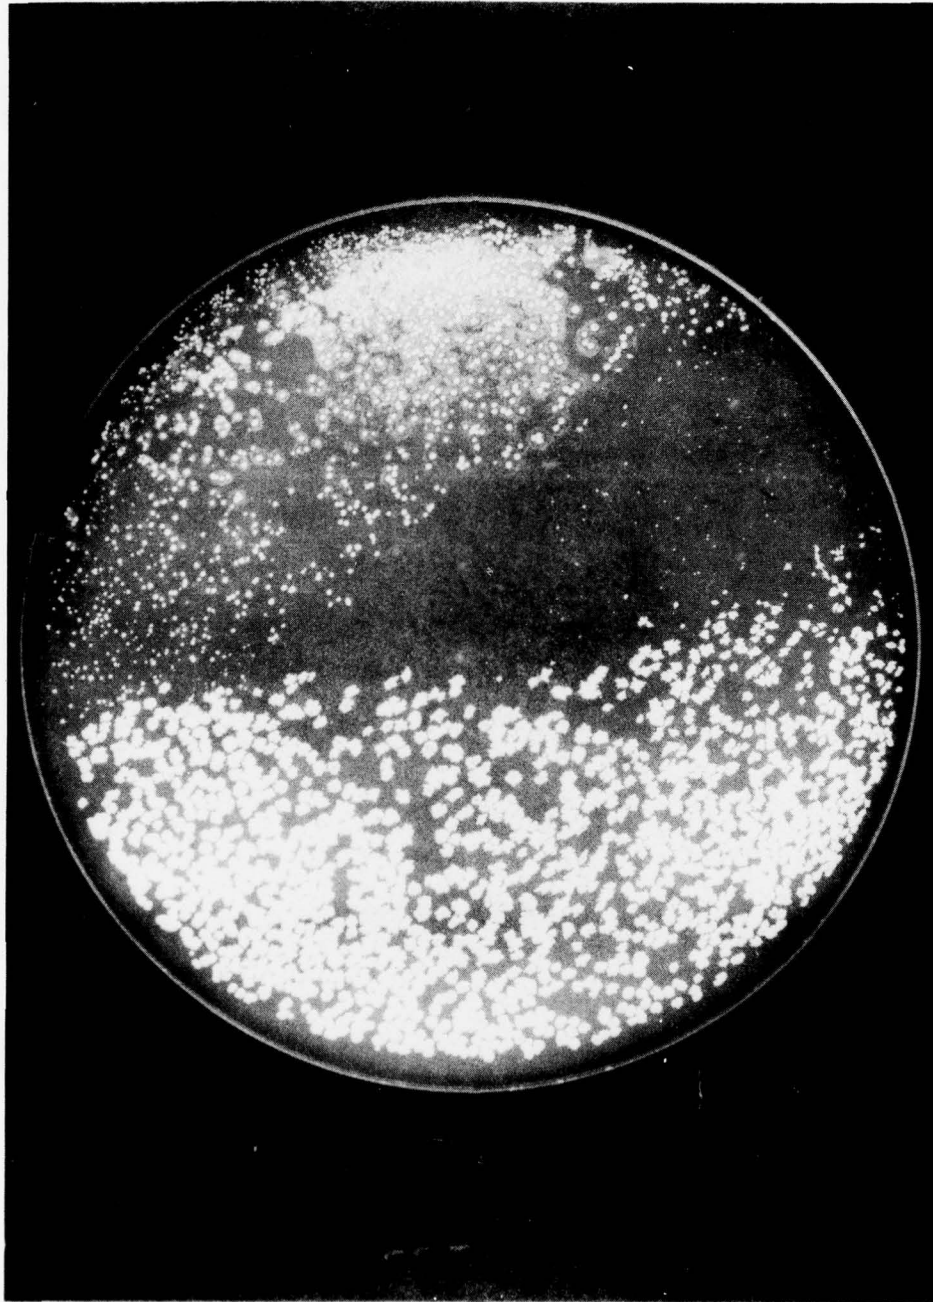
Figure 58. A specimen coated with Exotic Materials AR coating, after indoor electric current testing for four hours; 0.5 amps for 60 volts.

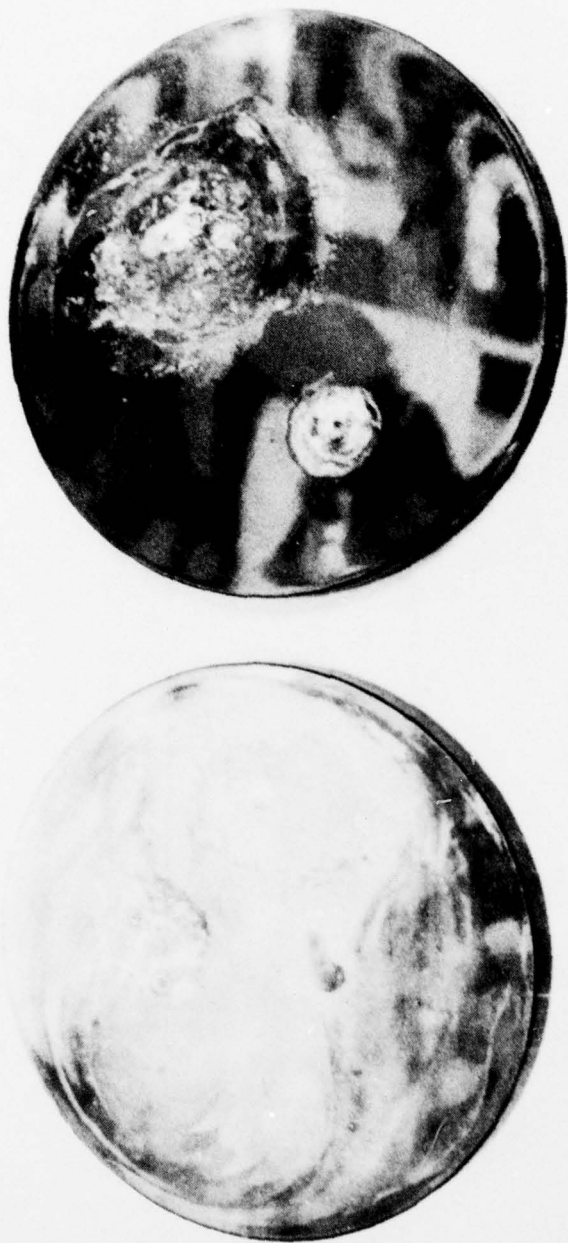
Figure 64. Transmittance of 0.25-inch-thick germanium specimens with Optic Electronic XF 27 single layer anti-reflection coating on both sides, before and after 4-month exposure to sea water with natural circulation.

2. Germanium specimens coated with anti-reflection coatings corrode to varying degrees depending on the particular coating. The specimens with the Exotic Materials' single-layer anti-reflection coating sustained the least amount of damage of any of the coated specimens. These specimens also exhibited the least drop in transmission after exposure to seawater. After 120 days submersion in seawater, the transmission through specimens with EM #40104 and OE XF 27 single-layer AR coatings decreased 5 and 22 percent, respectively.

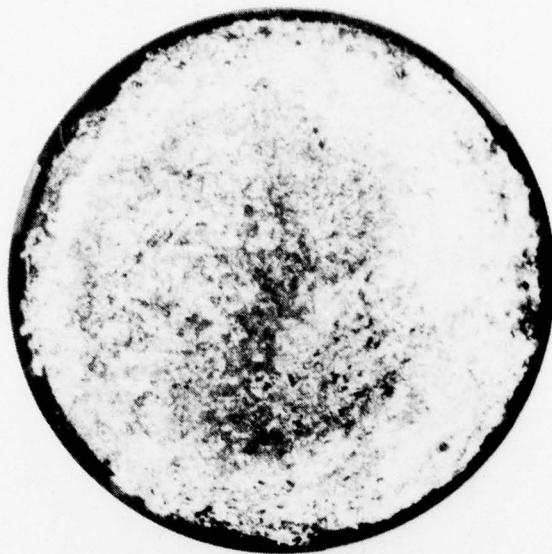
Figure 70. The effects of forced circulation contrasted with that of natural circulation, on a specimen with the Optic Electronic single layer anti-reflection coating XF 27.

FORCED CIRCULATION

3. Forced circulation had the intended effect of decreasing the amount of growth on the surface of the specimens. However, the forced circulation also led to a more rapid decay of some of the specimens' coatings and surfaces (figure 70), though the coatings of other specimens did not show a noticeable difference (figure 71). Further testing would have to take place to determine whether the damaging effects could be minimized through changes such as altering the flow rate, while maintaining the benefit of hindering the marine growth.
